# Summitville Update

COLORADO DEPARTMENT OF PUBLIC HEALTH AND ENVIRONMENT  
U.S. ENVIRONMENTAL PROTECTION AGENCY

## SUMMITVILLE WATER TREATMENT HAS RECORD YEAR ABOVE AVERAGE SNOWPACK TESTS REMEDIAL PERFORMANCE

## SUMMITVILLE WATER TREATMENT 101

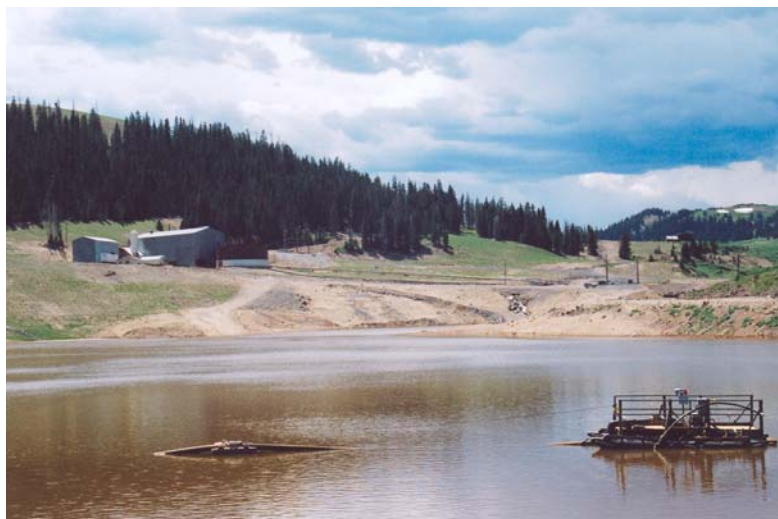
The Summitville Dam Impoundment and water treatment plant are the heart of Summitville's water treatment system.

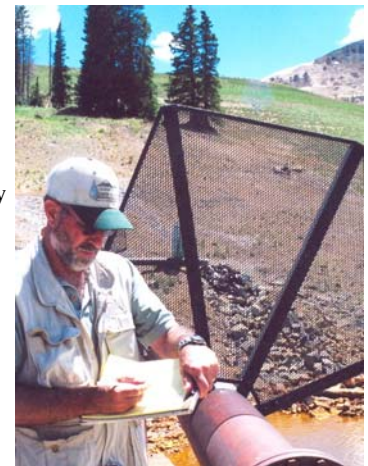
A Division of Water Resources inspector takes notes during the inspection of the Summitville Dam Impoundment.

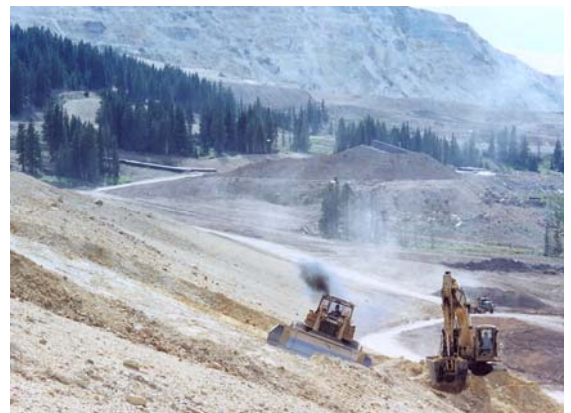
Summitville in 2000; site-wide reclamation work consisted of grading, ditch construction, soil

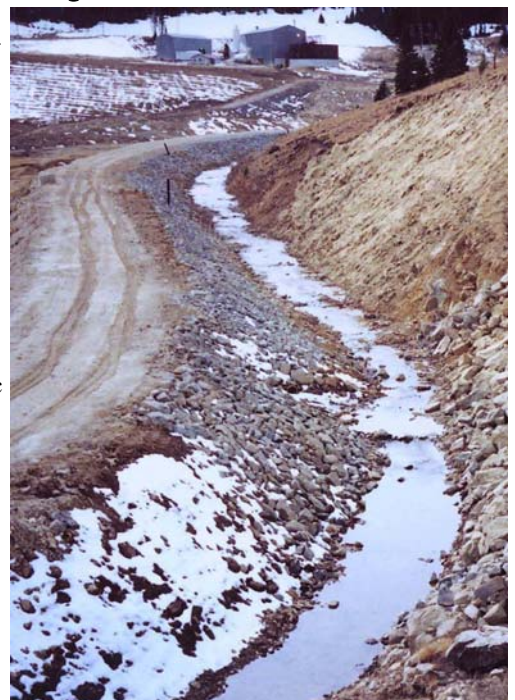
**The Wightman Fork Diversion directs the waters of Wightman Fork around the SDI.**

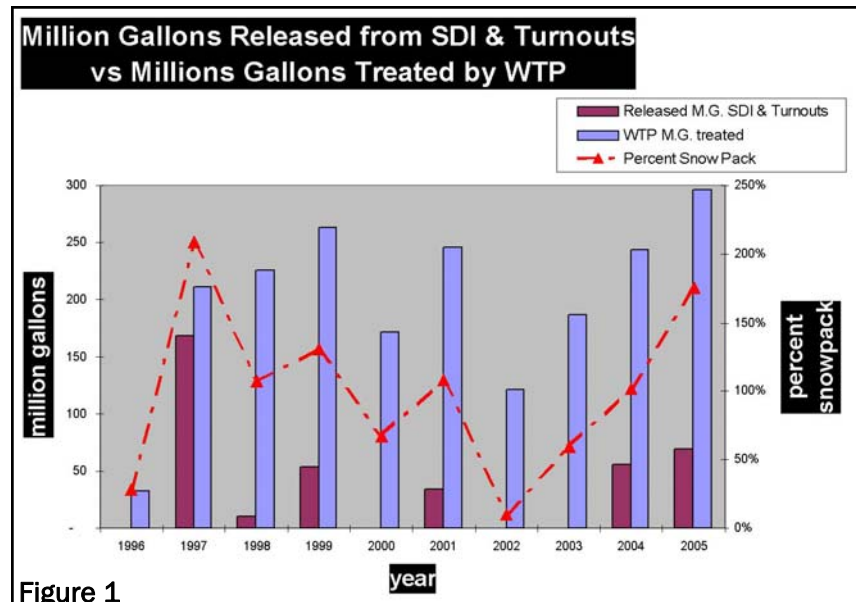
Figure 1

With a little planning, initiative, and some duct tape, Summitville achieved a record year of water treatment, approaching 298 million gallons (see Figure 1).

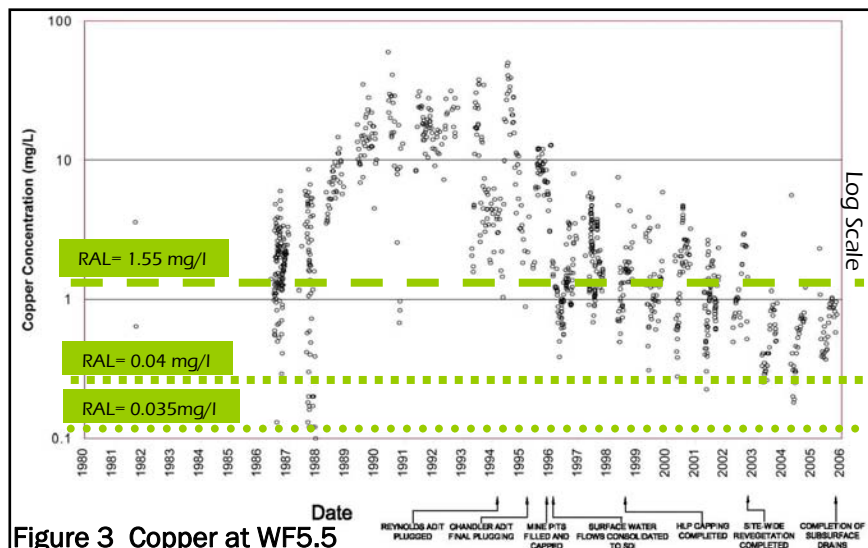
Figure 3 Copper at WF5.5

While there has been a significant reduction in copper released from the site over the last decade, figure 3 shows that the site continues to exceed the seasonal remedial action levels for copper at WF5.5. This is due in large part to the inability to collect and store all contaminated water generated by the site.

As per the remedial levels at WF5.5, copper concentrations should be less than 1.55mg/l during spring runoff and less than 0.4mg/l or 0.035mg/l after spring runoff and when the pH is above or below 6 standard units respectively. Seasonally, copper concentrations at WF5.5 meet remedial action goals during heavy spring runoff, but fail for the remainder of the year.

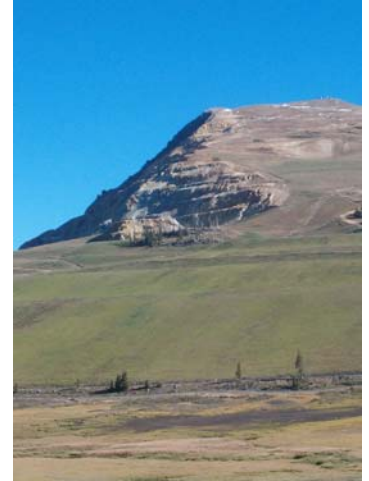
South Mountain, the High Wall and the North Waste Dump in the foreground, viewed from the northwest.
